DSTO-GD-0123

Atmospheric Corrosivity of Defence
Bases in Northern and Eastern
Australia

B.S. Smith, E.J. Duxbury and
B.T. Moore

**Ship Structures and Materials Division
Aeronautical and Maritime Research Laboratory**

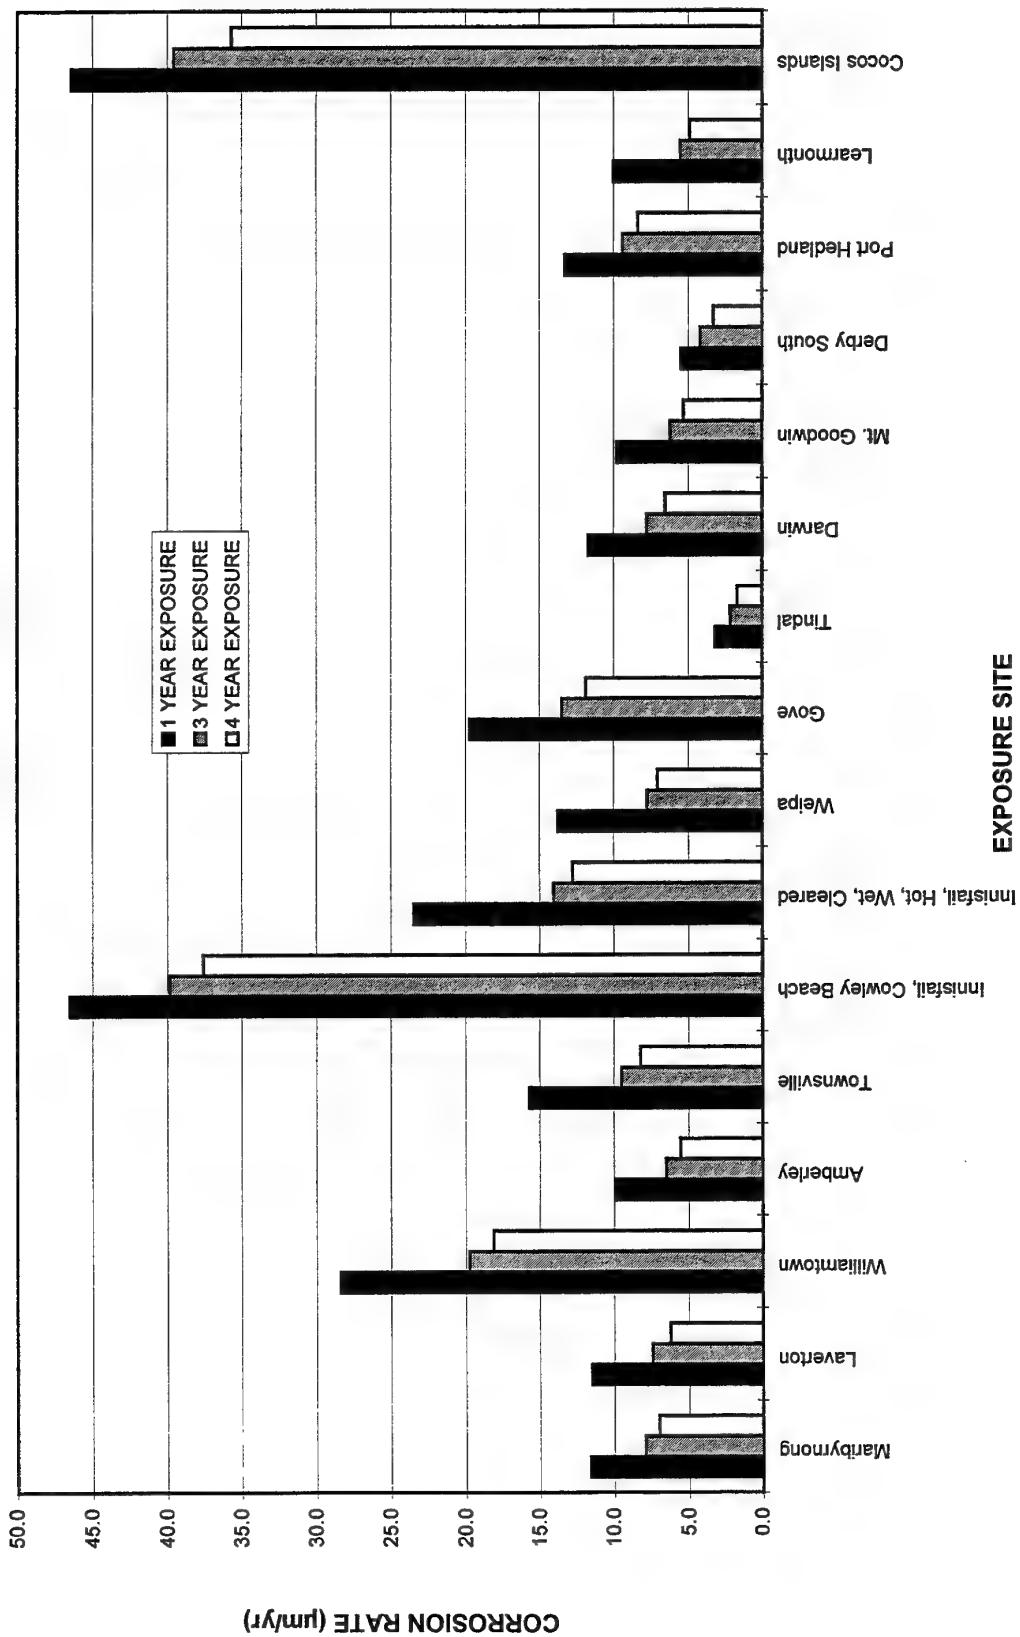
FIGURE 5
CORROSION RATES OF STEEL AT THE VARIOUS SITES

Corrosion rates for copper-steel determined in this study (Figure 5) fall within the broad range of rates for steels found elsewhere over many years. Copper-steels and other low alloy steels generally have lower corrosion rates than carbon structural steels in any given environment¹³⁻¹⁵, the type used in this exercise being considered to corrode at about half the rate of structural steel.

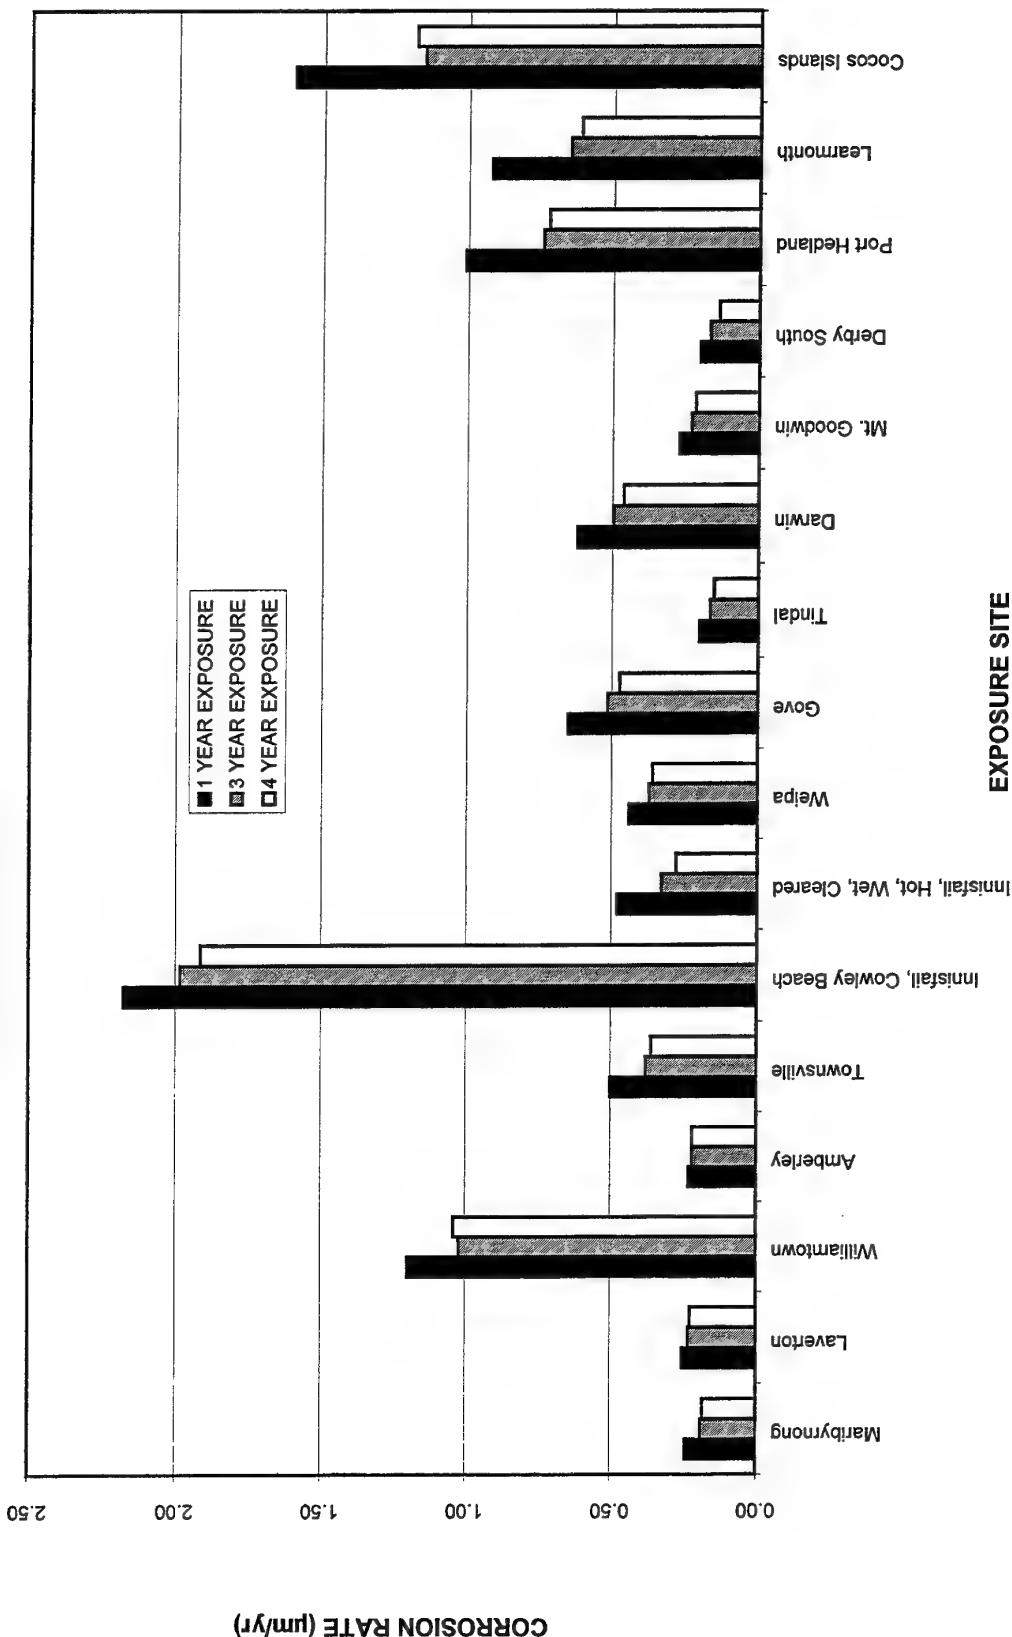
FIGURE 6
CORROSION RATES OF ZINC AT VARIOUS SITES

The corrosion rates for zinc are shown in Figure 6 and are comparable to those found by other workers for similar climatic conditions. As can be seen in the comparison chart of Figure 9, zinc corroded far more slowly than steel in the various locations. Typical panels are shown in Figures 14 and 15. Note the staining by red dust at Port Hedland and the effect of prevailing wind direction at Cowley Beach.

It is commonly considered that the corrosion rate of zinc is nearly independent of time of exposure¹⁶, i.e. that its average corrosion rate over 3, 4 or more years will be similar to its corrosion rate over one year, in contrast to that of steel. This is true of two locations (Laverton and Amberley) in this study; however, it can be seen in Figure 6 that for the remainder of the sites the corrosion rates over the longer periods are often similar, but are significantly less than the one year results. For example the 4 year rates are on average only 77 % of the corresponding 1 year rate.
